DATE: September 6, 2019
TO: PROSPECTIVE CONSULTANTS
SUBJECT: **RFP FOR PARKS AND RECREATION MASTER PLAN UPDATE (PROJECT NO. 5115) - QUESTIONS AND CLARIFICATIONS No. 1**

FACILITY CONDITION ASSESSMENT

City of Milpitas
1265 North Milpitas Boulevard
Milpitas, California 95035
Tony Ndah

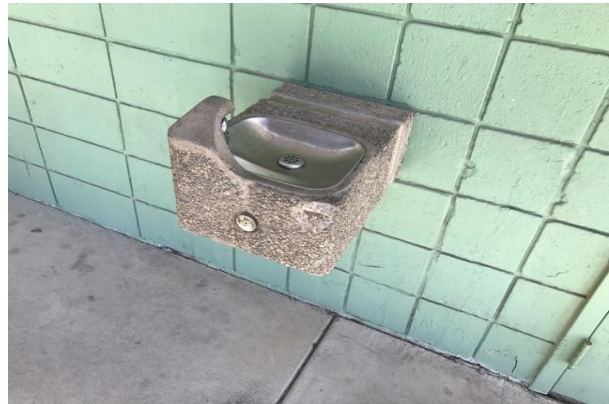
#24 AUGUSTINE DRINKING
FOUNTAIN, DAMAGED

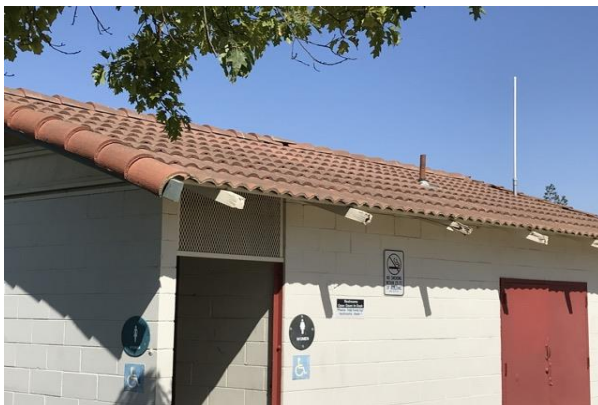
#29

GILL, DAMAGED RAFTER TAILS

Termite damage and/or dry rot were noted in several restrooms. A professional consultant must be retained to analyze the existing condition, provide recommendations and, if necessary, estimate the scope and cost of any required repairs. The cost of this study is included in the cost tables. A budgetary cost allowance to replace the roof structure is also included.

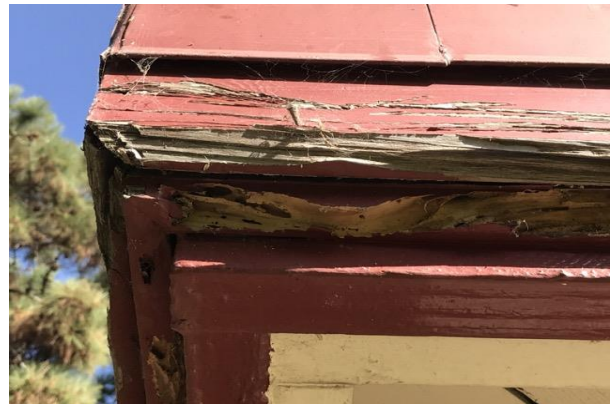
#40

STARLIGHT, TERMITE/ROT
DAMAGE

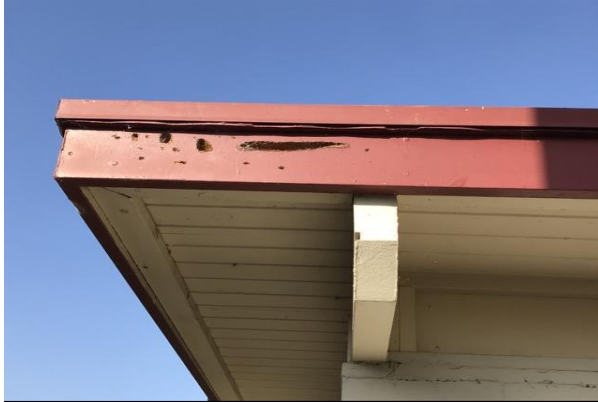
#49

HALL MEMORIAL PARK, FASCIA
DAMAGE

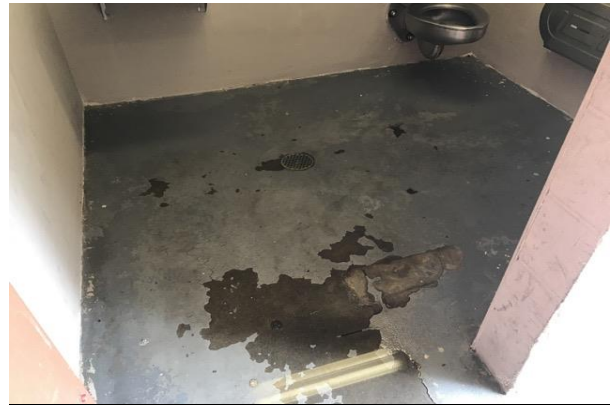
#62

PINEWOOD EPOXY FLOOR
COATING DEGRADATION

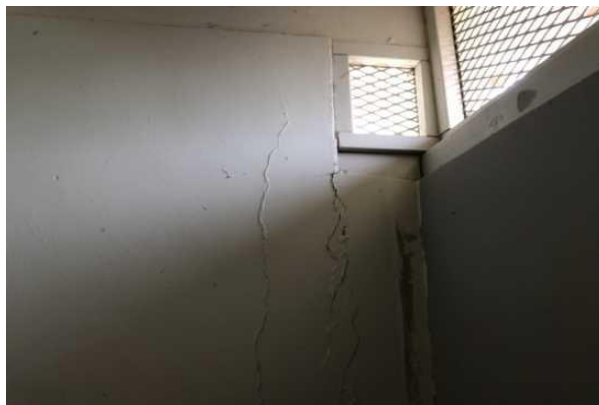
#65

Most of the restrooms have concrete masonry unit (CMU) wall construction and wood framed roof construction. Most of the CMU walls look good, two restrooms, Hall and Foothill, were noted to have significant vertical cracking. All the modified bituminous roofs are nearing the end of their lives and will need replacement within the next three years. Termite damage and or dry rot were seen in approximately half of the restrooms. Interior and exterior painting is budgeted and anticipated.

FOOTHILL PARK, STRUCTURAL
CRACK

There is possible structural damage at Foothill Park. A professional engineer must be retained to analyze the existing condition, provide recommendations and, if necessary, estimate the scope and cost of any required repairs. The cost of this study is included in the cost tables. Due to the ambiguity of the required repair scope at the time of this assessment, the cost for any possible subsequent repairs is not included.
